## ACCIDENT/INCIDENT ALERT

December 2004

# TYRE EXPLOSIONS FROM LARGE STEEL WHEEL RIMS

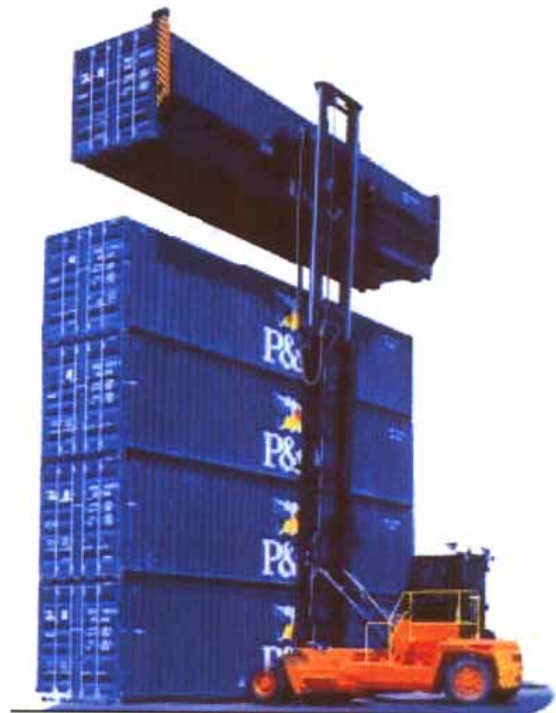
Figure 1: Forklift has dual load-bearing wheels at the front; single steering wheels at the back.

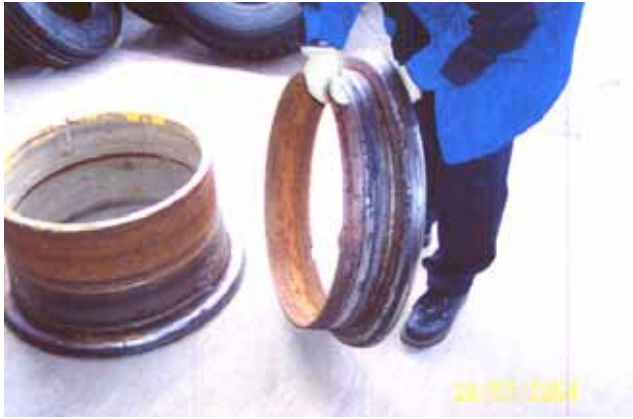
Figure 2: Assembly of wheel components. Rim base and flange on the ground; second flange being fitted; bead seat band between feet of fitter.

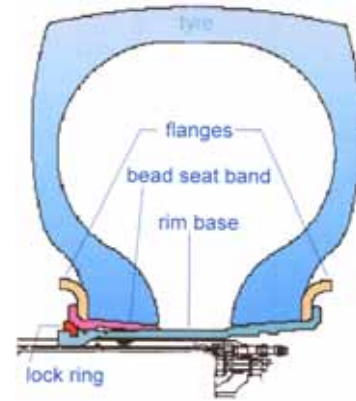
The wheels are centred onto the axle hubs by a “spade” or wedge. The wheels have a split rim with a locking ring that sits into a groove in the outer flange of the rim (see Figure 3). The whole assembly is attached to the wheel hub with a series of clamps and locking nuts. Tyres are regularly rotated so that they wear evenly.

Figure 3: Section through tyre and wheel assembly showing rim components.
