ACCIDENT/INCIDENT ALERT

No. 16, August 2006

Kinghitter Series III Post Driver Fatality

Series III Safety Bolt Kit Upgrade

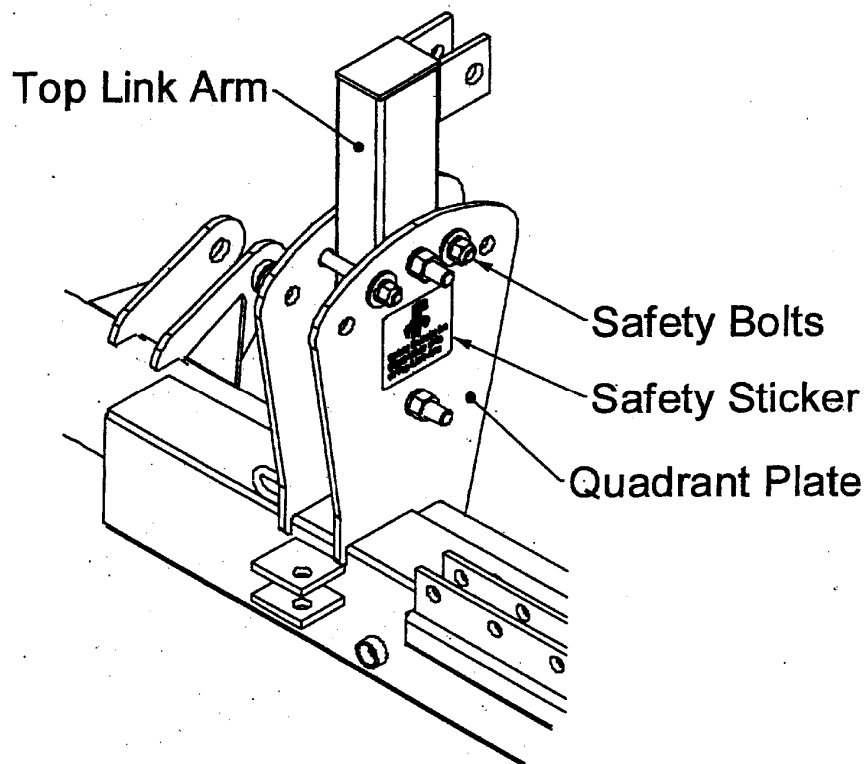
The accident was caused by a broken top link bolt which, having fractured, worked its way completely out of the top link arm resulting in the post driver mast falling and striking the operator fatally injuring him.

An analysis by SGS M&I of the recovered broken bolt found it had been subject to a repetitive loading process that had produced a fatigue crack that eventually led to the bolt being unable to support the load. The conclusion reached from the analysis undertaken was that the grade of bolt used to secure the Series III top link arm was not adequate for its task.

Please replace the bolts holding the top link arm with the longer high tensile bolts supplied and fit extra safety bolts (M16) either side of the top link arm. Clean the side of the quadrant plate for placing the safety sticker indicating the requirement for safety bolts. Nuts and safety sticker should face the operator as shown.

Ensure the beam is supported when you are changing the bolts
