ACCIDENT/INCIDENT ALERT

April 2002

Fatal Drilling Accident at a Quarry

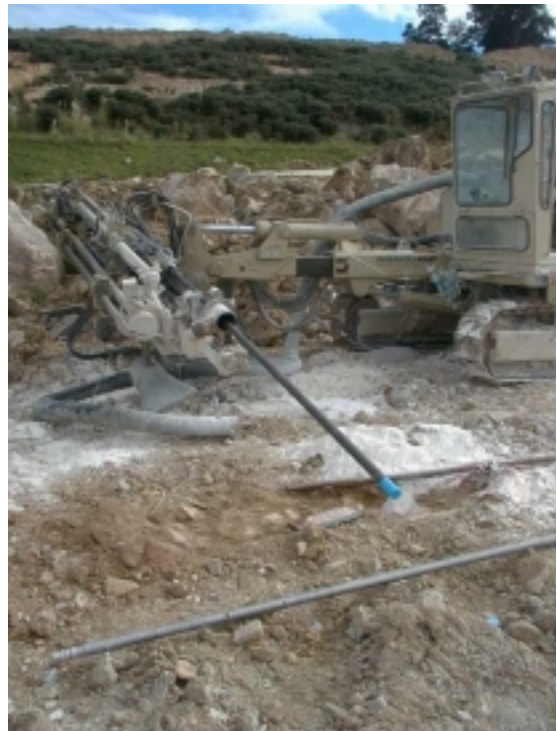
A driller sustained fatal injuries at a limestone quarry in Northland. No one witnessed the accident but it is evident that his overalls became entangled while he was attaching a new drill rod to the drill's shank adapter. His body was found tightly bound onto the rotating drill rod.

To install a new rod into the automatic rod changer rack, it needs to be attached to the drill's shank adapter first and he was doing this with the drill shank rotating at about 60 to 70 rpm. The drill carriage was positioned about a metre above the ground surface as shown in the photograph.

The 3.66 metre-long rods weigh 43.5 kg and being heavy, he was probably holding it up against his body at about hip level as he placed the end onto the rotating drillshank.

Drillers should be alerted to the hazard of working near rotating drill steel and, in particular, warned never to attach rods, couplings or bits to a rotating part.
