ACCIDENT ALERT

Serious port accident—worker struck by steel band

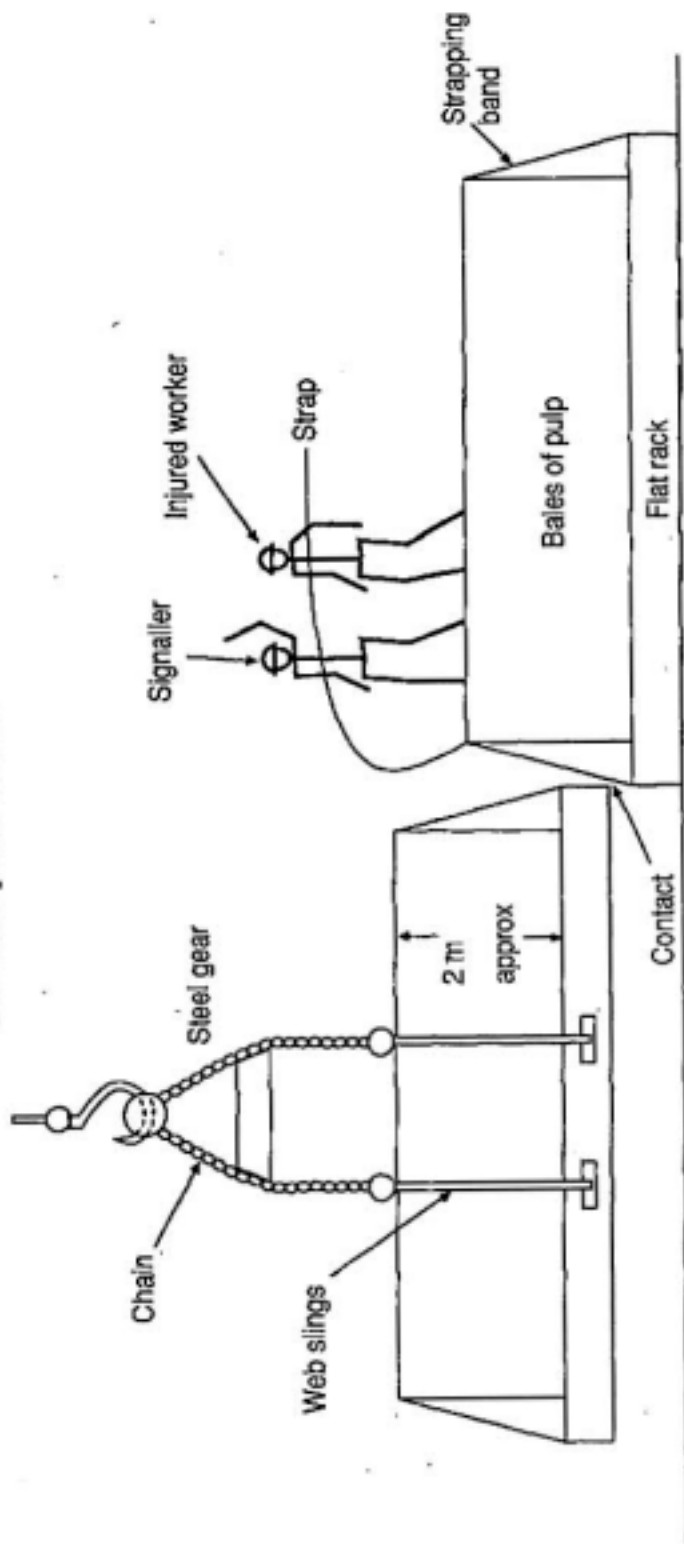
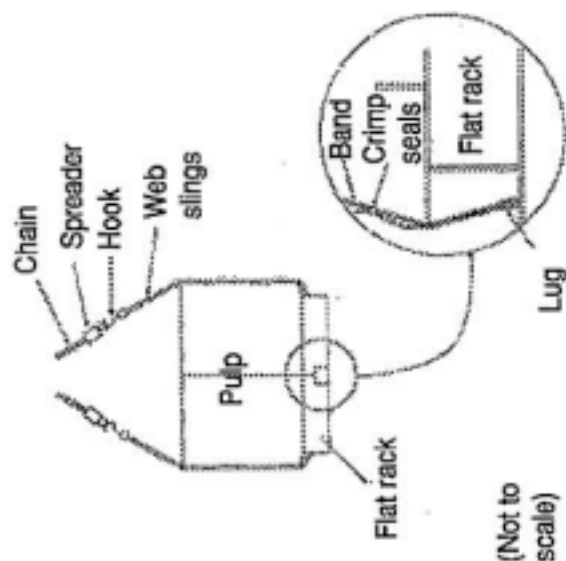
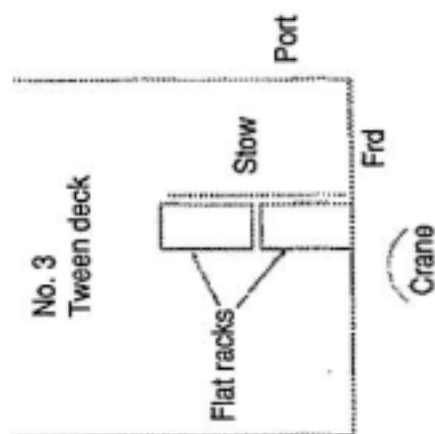
After a 20 foot flat rack loaded with pulp and having a total weight of 20.4 tonnes had been stowed, a similar unit was to be placed next to it as shown in the diagram. The flat racks were to be end to end, and were part of a consignment of 12 similar units. One general hand and the signaller were standing on top of the first unit. The second unit was landed and then floated to bring it into position.

As the load floated, it swung towards the end of the unit on which the men were standing, and broke the steel band securing the pulp to the flat rack. The band was under tension and sprung back between the two men. The steel band hit the general hand in the face, causing serious injury.

Although bands are quite often broken by contact with forklift tynes and with other cargo, there have apparently been no problems and the bands have not been recognised as a danger. A relatively large amount of potential energy is stored in the longitudinal band fitted to pulp on flat racks, due to compression and the length of band, which is about 10 metres. It is therefore considered that these bands under tension are a greater hazard than the shorter transverse bands, or bands fitted to steel cargoes.

Employers and workers need to be aware of the potential danger from strapping bands that are under tension. Workers should stand clear when there is risk of contact between the bands and other cargo or equipment.

OSH is liaising with industry to see whether better procedures for strapping the product to the base are available or can be devised.
