# Safety Lines

ENGINEERING SAFETY NEWSLETTER, OCCUPATIONAL SAFETY AND HEALTH SERVICE

No. 40,  
December 1998

## Seizure of Boiler Relief Valves

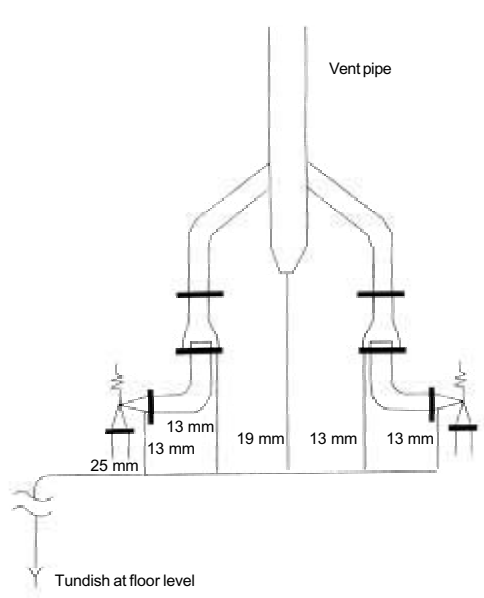
Figure 1. Typical relief valve drainage system.

Examination of the relief valve discharge pipework revealed that all the drains from the discharge side of the valves were connected to a common header which ran to a tundish some 24 m away — see figure 1. The drain lines were 13 mm and 19 mm nominal bore carbon steel and the header 25 mm nominal bore carbon steel. Blockages in individual drain lines could not be checked. Both relief valve outlet bends were badly scaled and corroded due to water standing in the extension pieces. These sections had already been renewed on other boilers. The extension pieces were badly scaled and full of deposits. The drain line was badly scaled reducing the bore from 13 mm to 6 mm. There were also indications on top of the boiler that condensate/water had been dripping from the relief valve discharge extension pieces.

- The relief valves failed to lift due to blockages in the discharge pipework draining system which led to corrosion and scaling of the valves.
- The outlet lines and vent were badly scaled internally such that when the relief valves were floated, debris and scale fell back into the expansion pieces and valve outlets. This debris could then block the drain lines.
- Water/condensate collected on the outlet side of the valves where evaporation caused the build up of scale and precipitation of deposits rendering the valve inoperable.

- The relief valve drains on all boilers should be modified to provide individual short lines of adequate size to a tundish within approximately three feet of the item being drained. Checking/washing through of the drain lines and the tundish lines should be included in future boiler surveys.
- Formal checking of drains/tundishes by operating personnel should be introduced.

- The relief valve vent lines should be renewed at the earliest opportunity and given a protective coating to reduce scaling. Other installations should be examined and if similar problems exist, modifications should be carried out to correct them.

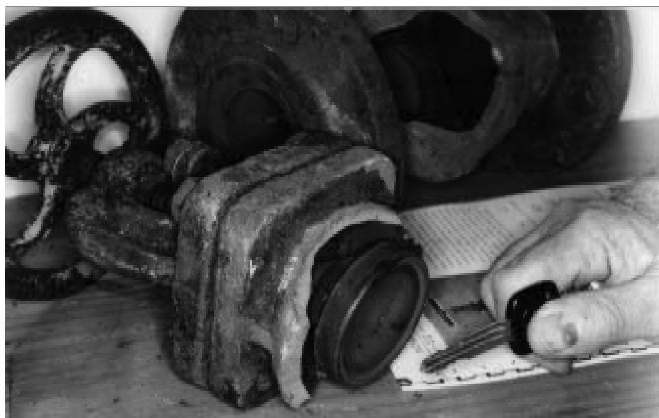
The photograph below shows a three-inch cast iron valve body which has been shattered just below the bonnet through waterhammer effect.

The failure occurred when an operator opened the main steam stop valve in an adjacent area of the plant. This was done in the belief that any residual condensate would have been drained from the steam line by the trapping system. Unfortunately, the system had not drained and valve failure occurred when it was hit by a slug of water.

Fortunately, no one was injured and a procedure has been put in place that puts emphasis on draining and warming the system during the start up.

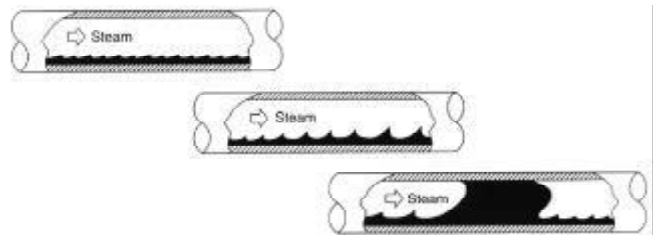
Waterhammer may occur when condensate is pushed along a pipe by the steam instead of being drained away at the low points, and is suddenly stopped by impacting on an obstacle in the system. The build up of droplets of condensate along a length of steam pipework eventually forms a solid slug which will be carried at steam velocity along the pipework. Such velocities can be of 30 m/s or more. This slug of water is dense and incompressible and, when travelling at high velocity, has a considerable amount of kinetic energy.

Figure 2. The formation of a 'solid' slug of water.

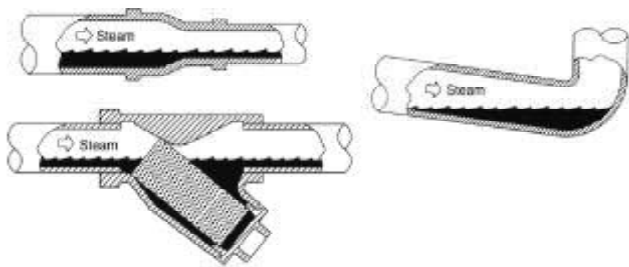
- Sags in the line.
- Incorrect use of concentric reducers and strainers. For this reason it is better to fit strainers on their sides in steam lines.
- Inadequate drainage of steam lines.

Figure 3. Potential sources of waterhammer trouble.

- Steam lines should be arranged with a gradual fall in the direction of flow, with drain points installed at regular intervals and at low points.
- Check valves should be fitted after all traps which would otherwise allow condensate to run back into the steam line or plant during shut down. Isolation valves should be opened slowly to allow any condensate which may be lying in the system to flow gently towards, and through, the drain traps before it is picked up by high velocity steam. This is especially important at start up.
