Safety Lines

Water Drum Mismatch

Issued by the Department of Labour, New Zealand

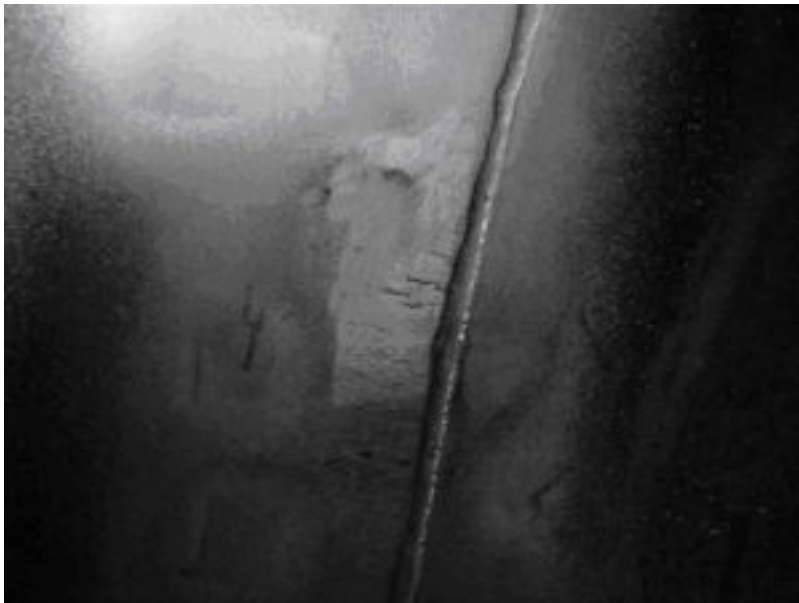
The first indication that something was wrong was when the radiographic report of one of the head circumferential seam welds highlighted cracking in the head parent metal perpendicular to the weld seam. Subsequent visual and surface methods inspection using magnetic particle inspection (MPI) revealed numerous cracks around the entire circumference.

The basic details of the head from the forming certificate confirmed, among other things, that the plate material was ASTM A516-03 Gr 70 22.0mm thick, the ID was 762mm, and there was no heat treatment after forming. The thickness around flange and knuckle generally ranged from 19.05 - 19.76mm with a minimum thickness of 18.7mm, it had a thickness loss greater than 10%, and it had been cold formed - spun with no heat treatment. The head certificate also stated the heads conformed to ASME Sec VIII Div 1, although the heads were supposed to be supplied to AS 1228.

Section 6.3.1 of AS 4458 - 1997 Pressure equipment - Manufacture allows for cold forming, but if the fibre strain is greater than 5% (as calculated in accordance with the standard) and if the dished end thickness exceeds 16mm the heads need to be heat treated. The actual strain was found to be 12.4%.

Typical cracking initially seen with MPI

The initial reaction of the manufacturer was to grind the cracks out and repair by welding. However both water drum heads were cut off and discarded at the insistence of the vendor and third party inspection body, with new heads being ordered using the correct thickness plate. The barrel was cleaned up and the joint preparation re-made with additional surface methods on the preparation faces and heat affected zone from the previous weld to ensure against cracking or laminations at the face and adjacent parent metal.

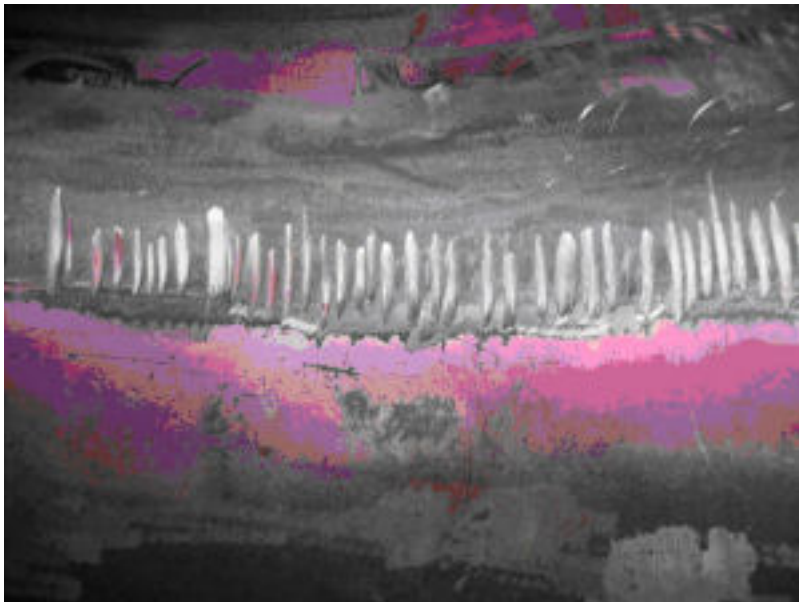
During grinding out of cracks by manufacturer.
