ACCIDENT/INCIDENT ALERT

9 February 2004

Scannells Multi-Purpose Bale Wrapper WPW – 200/2

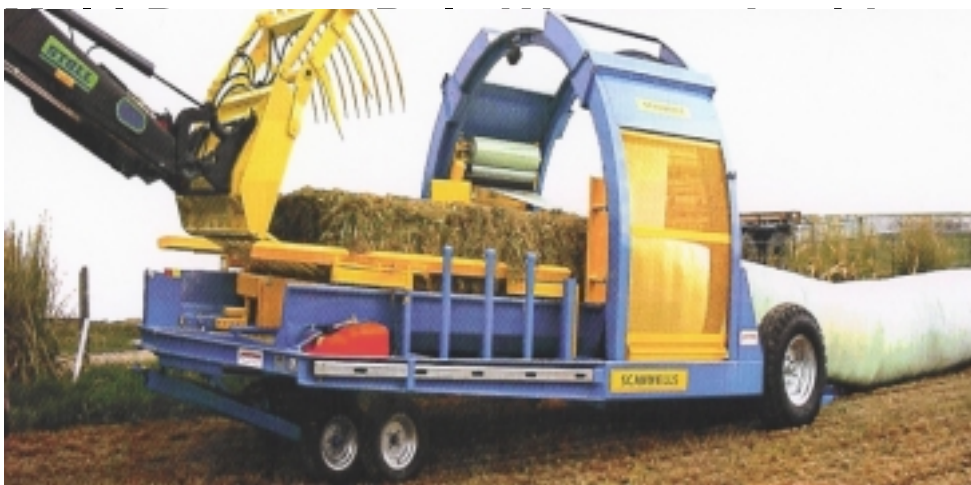
A baler operator received multiple facial fractures when his head was caught in the wrapping ring while he was manually pulling the film down to set up the first bale to be wrapped.

The operator lifted the side guard on the bale wrapper to pull the wrap over the rollers so the applicator could wrap the first bale. As he was pulling the wrap over, the loader operator loaded a bale on the back of the wrapper activating the first cycle of the wrapper trapping the victim's head.

- The side guards were not interlocked with the power source, which allowed the wrapper to operate with the guards up.
- The employee had been provided with poor information and training, contributing to the accident.

The side guards need to be interlocked with the power source to prevent the wrapper operating if the guards are not closed. (All owners and operators should consult the manufacturer – B J Scarlett Ltd. Timaru.)

All operators should be provided with adequate information and training.
