Bulldozer Brake Failure

INCIDENT

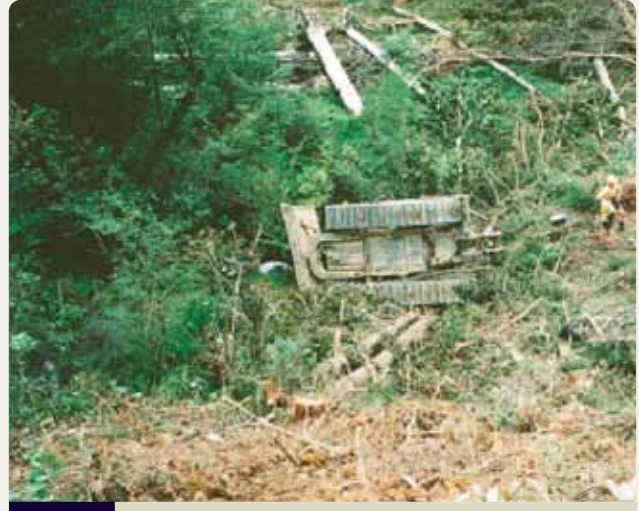
1

He was operating a Caterpillar bulldozer (Model 527) to extract logs. He was about to pull a third drag of two logs up a 34 degree slope to the skid site, but before he had started to winch the logs, the machine ran backwards over the edge of the track and down the hill, coming to rest 40 metres below. The worker was found unconscious and unrestrained in the cab.

View of the toppled bulldozer where it came to rest.

Seatbelts must be worn when operating plant with ROPS.

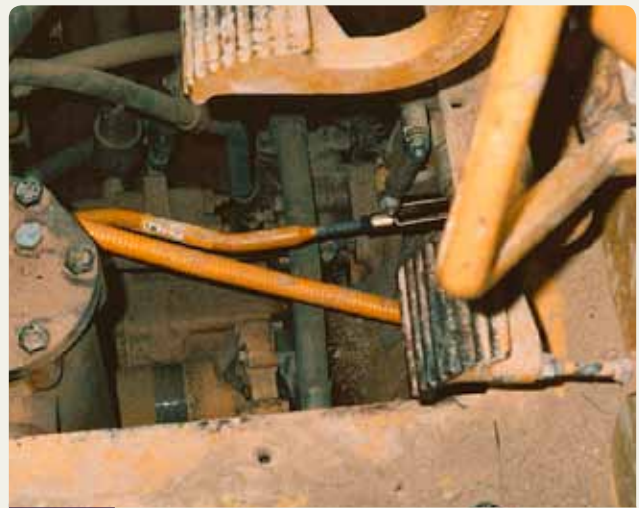
2

- An analysis by a metallurgy consultant revealed that the brake linkage may have been bent and straightened some time prior to the accident, and subsequently broke. The consultant expressed the view that this bend would have not been sufficient to cause the failure. Instead, he felt the damage to the brake linkage may have been caused by incorrect routing of a hydraulic hose, generating additional fluctuating stress along the threaded portion, and leading to fatigue cracking.

- It is possible that the initial damage inadvertently occurred during maintenance or repair work, e.g. standing on or levering off the linkage; or during initial manufacture of the machine.

View of the newly-fitted brake rod.

It is important to be aware that damage could occur to safety-critical parts such as brake linkages during maintenance and repair work. Such parts should be checked before the machine is put back in service.

Hydraulic and transmission hoses should be checked to ensure that they are refitted/replaced to the manufacturer's specification, and not placed in a position where they may affect other parts.
