Safety Lines

ENGINEERING SAFETY NEWSLETTER, DEPARTMENT OF LABOUR

No. 69, March 2006

NEW AMUSEMENT DEVICE – SCALING NEW HEIGHTS

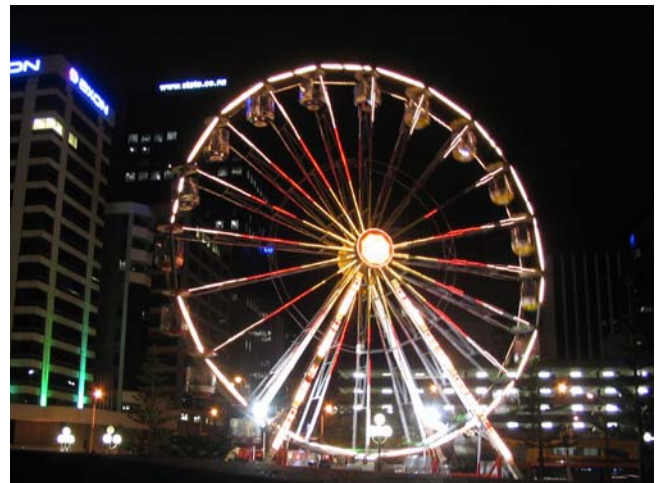
This device, which was manufactured in Italy in 2003, is somewhat different from the traditional Ferris wheel design, in that the passengers, instead of being seated in chairs, are carried in glass-surrounded modules, or gondolas. Entry and exit is by way of a hinged door, locked from the outside. The main piece of equipment is a large wheel structure reaching 30 metres from the ground and weighing in excess of 60 tonnes. The whole device, despite its impressive dimensions, is referred to as a 'trailer model', and is transported on two articulated trailers. It takes about 20 hours to set up. There are 20 gondolas, in each of which up to six adult riders can be seated. Ferris wheels are the highest passenger-carrying capacity amusement devices, and the largest one based in New Zealand, by comparison, has a

The Giant Ferris Wheel

Uniquely, each gondola is also capable of being rotated (independently of the large wheel structure) by means of a centrally located handwheel within the gondola, which can provide an additional 'thrill' to the already impressive ride.

The picture shows one of the more glamorous items of equipment of professional interest to Engineering Safety. In January, this large Ferris wheel variant came to Auckland from England, bringing with it some interesting challenges for the engineering certification process. The owner, Mr David Taylor of Cumbria in England, informed us that his amusement device, known as the 'Giant Ferris Wheel', had already been operated in some exotic locations on different continents, and continues to be in demand.

means of passenger restraint to prevent riders from standing. This ride is designed such that no restraints are fitted at all and riders can move within the gondola whilst it is rotating, thereby creating a compliance issue. However, the certifying engineers, in addition to making the normal examination, carried out a risk analysis and satisfied themselves that it was intrinsically safe, enabling a Certificate of Examination to be issued, subject to certain operational conditions.

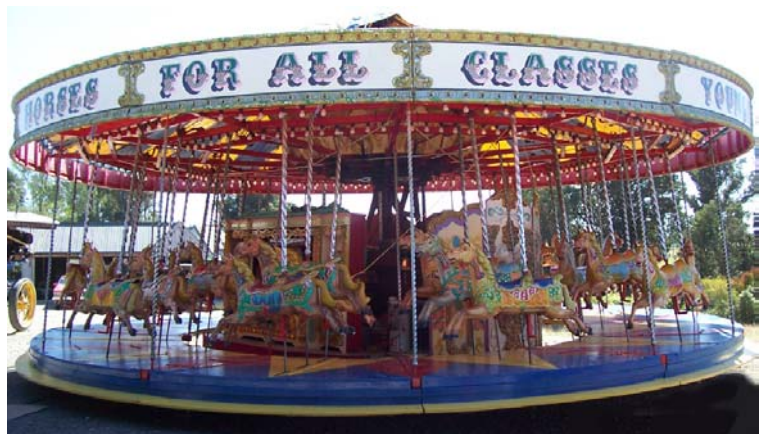
A second amusement device recently brought to New Zealand from the United Kingdom is a 'Vintage Merry-Go-Round', circa 1882. Now in Christchurch on loan to a local operator, the equipment is completely original and is a wonderful example from a bygone era, with carved horse figurines, a musical organ, and having its own steam traction engine of the same period to generate the power.

Classic old amusement device

This device has been inspected and certified in the normal manner with no engineering issues, despite its age.
