GUARDING FARM MACHINERY

Tractor power take-offs and transmission machinery

Published by the Occupational Safety and Health Service
Department of Labour
Wellington
New Zealand

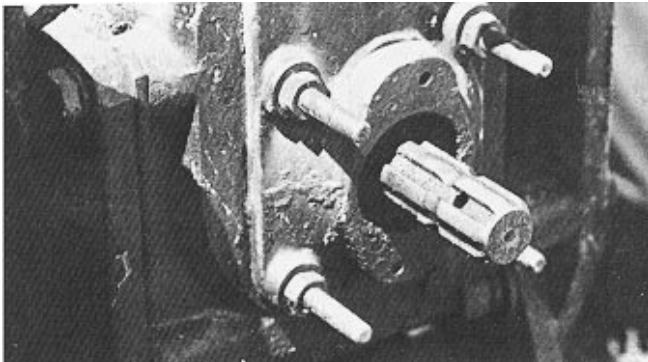
Fig. 1: Unprotected stub shaft.

Exposed power take-off stub shafts, couplings and drive shafts, as illustrated in figs 1 and 2, present a potential danger in that a person's clothing, hair, jewellery, hands, or even limbs can easily be caught and become wrapped around the shaft or coupling.

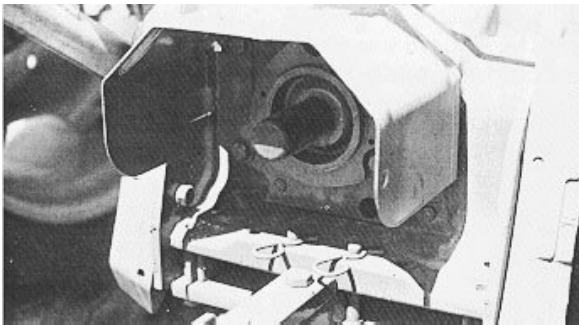
Fig. 3: Tractor protective shield with stub shaft cover.

Where clear access is needed to fit equipment, shields may be attached by hinges or lynch pins. Otherwise they should be firmly bolted to the tractor and driven unit. (See figs 3 and 5.)

When the tractor is in operation and its stub shaft is not in use, the power take-off drive should be disengaged. In addition, a cover should be provided over the stub shaft (fig. 3) to protect people and also to exclude dirt.

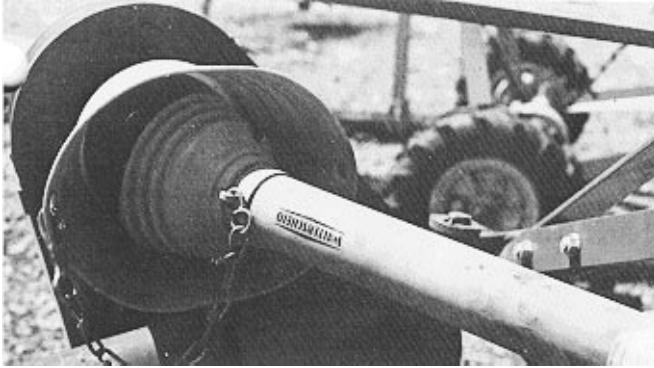
Fig. 4: Protective shield on driven unit.

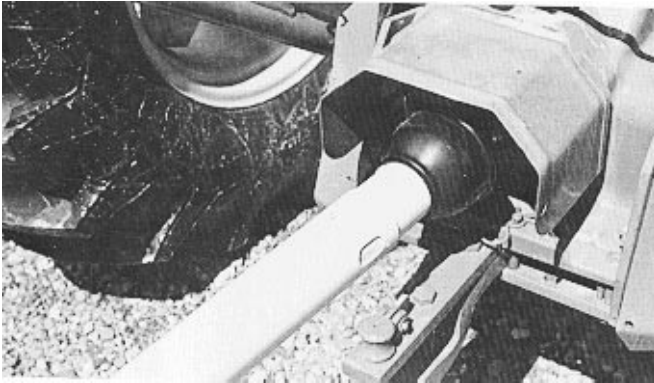
Fig. 5: Protective tube casing.

It is also essential that the drive shaft between the tractor and the machine or implement is guarded (fig. 5).

Experience has shown that the best method of guarding transmission shafts is by the use of cover tubes or casings which do not rotate with the shaft. The protective tube or casing should be fitted around the power take-off shaft on bearings and be anchored to a fixed part by means of a chain to prevent rotation.

Protective tubes or casings should have conical guards over the universal joints extending beyond the centre line of the universals and covered by shields at each end (fig. 5). A sectional view of a drive shaft and coupling guards is shown in fig. 7.

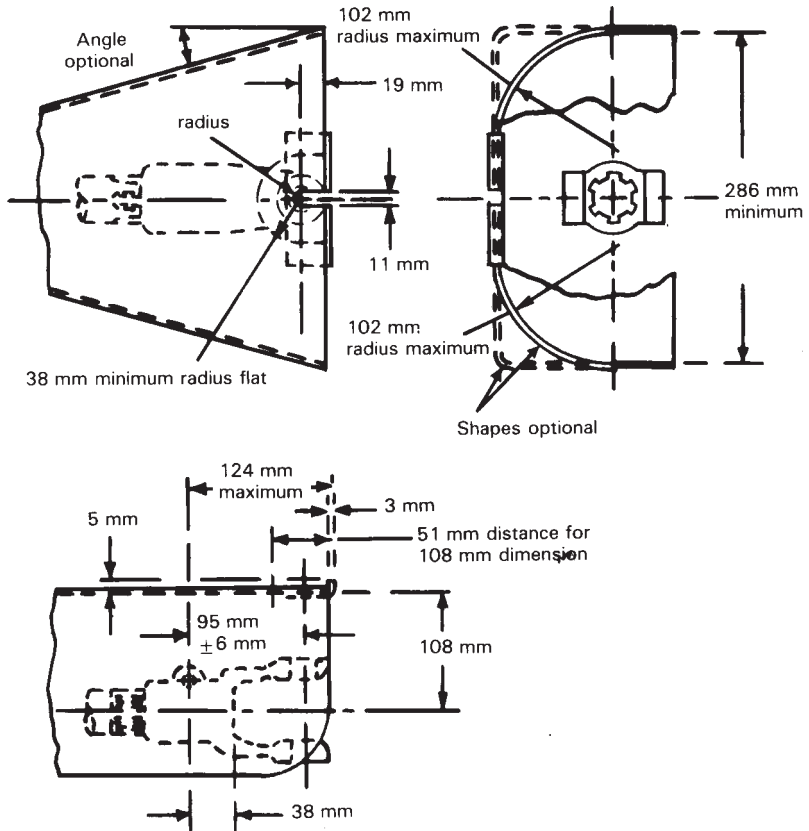
Fig. 6: Extract from BSS 1495 showing details of the tractor power take-off master guard or shield.

Suitable designs of guards for tractor stub shafts are shown in fig. 6.

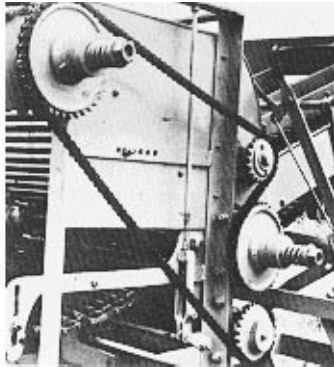
Fig. 9: Chain and sprockets.

These include nips formed between belts and pulleys, chains and sprockets, or meshing gears (as illustrated in figs 8-10).

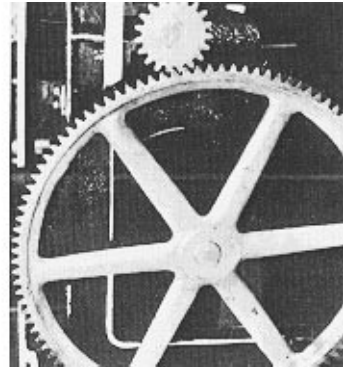
Fig. 10: Meshing gears.

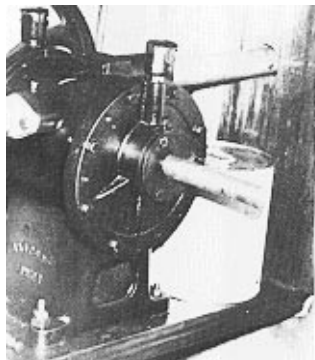
Fig. 14: Projecting spindle.

These include projecting vacuum pump shafts, motor spindles, line shafting, couplings and similar transmission.

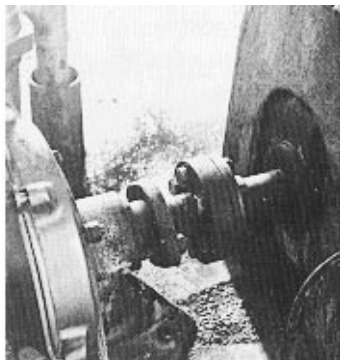
Fig. 15: Coupling.

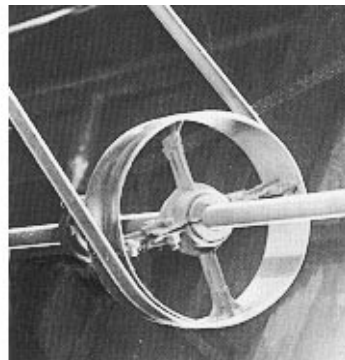
Fig. 16: Line shafting.

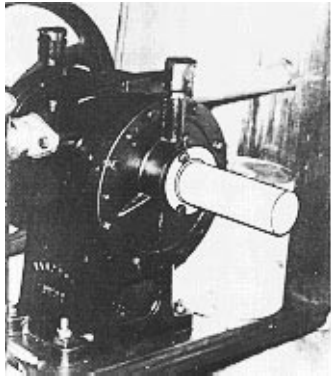
Fig. 17: Projecting spindle capped.

Shafts and spindles should be cut off flush with casings wherever practicable or be totally enclosed in sleeve- or cap-type guards constructed of suitable material, such as sheetmetal. Couplings may be enclosed with inverted U-section guards. Examples of effective guarding are illustrated in figs 17-19.

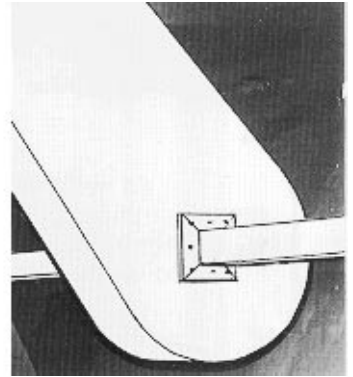
Fig. 19: Sleeve-type guard on line shaft
