ACCIDENT ALERT

Arm amputated by timber trimming saw

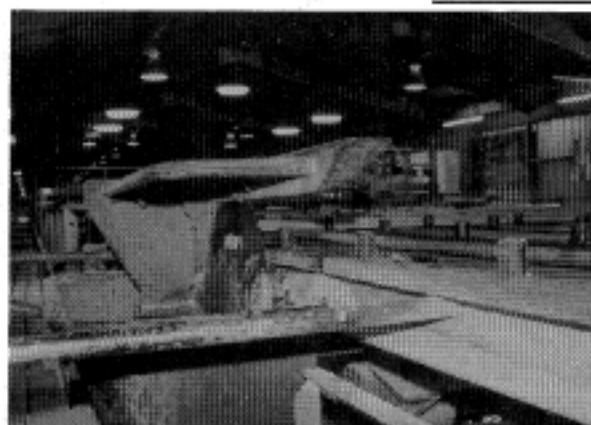
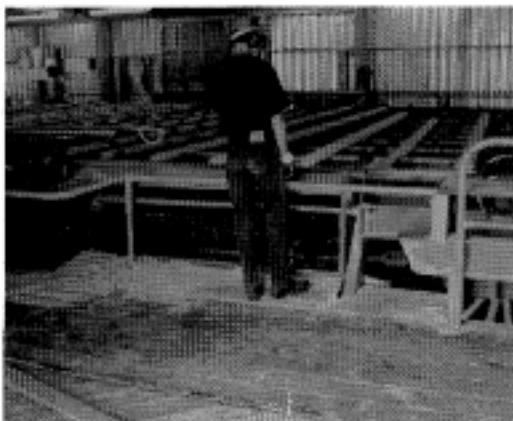
Steel barrier erected

However, at the inspector's suggestion, the company immediately erected a steel barrier (pictured) to create a physical barrier between the worker and the lug conveyor.

The investigation found no blame for the accident could be attached to the company. The operation does not normally require any person to work in close proximity to the saw, which is guarded to the maximum extent possible. The company could not reasonably have anticipated the possibility of a person collapsing at the work station and being carried along by the conveyor.
